The Stress Corrosion Cracking of Maraging Steels

A thesis submitted as a requirement for the degree  
of Doctor of Philosophy at the University of  
Newcastle upon Tyne.

P. M. Haigh, B.Sc.,

Department of Metallurgy,

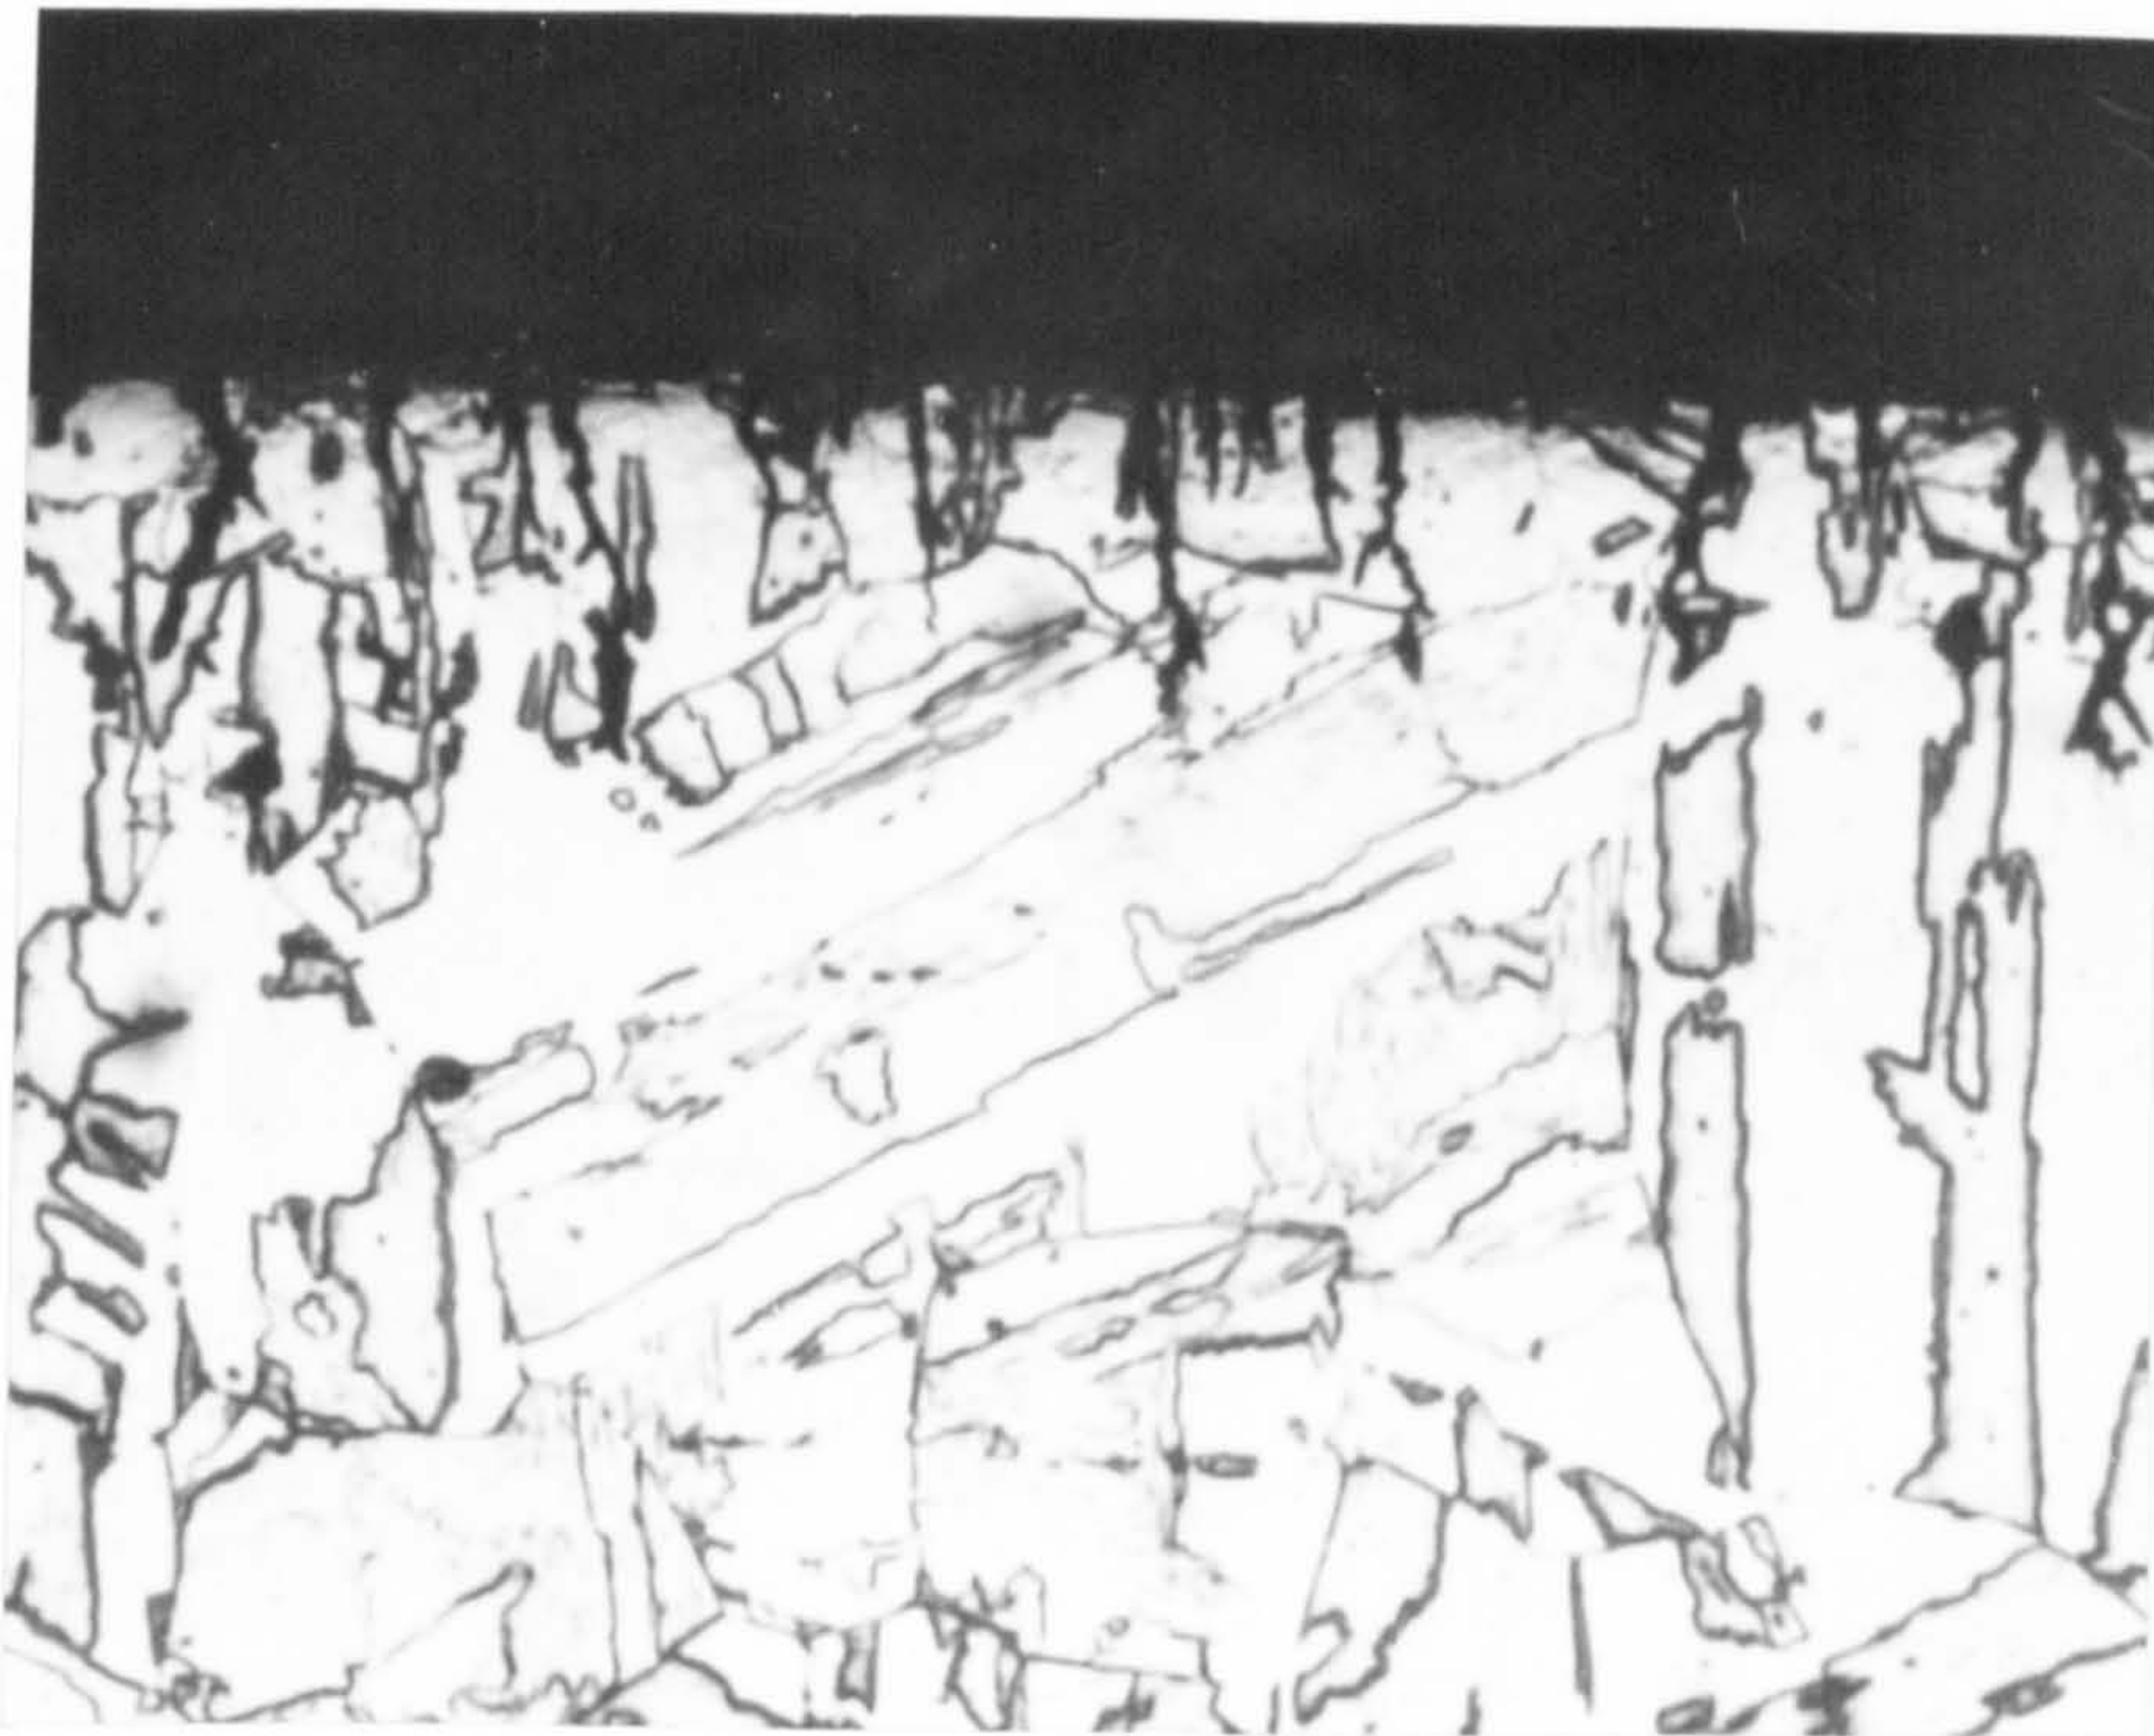
3.2 Surface fissures in an unaged material (600x)

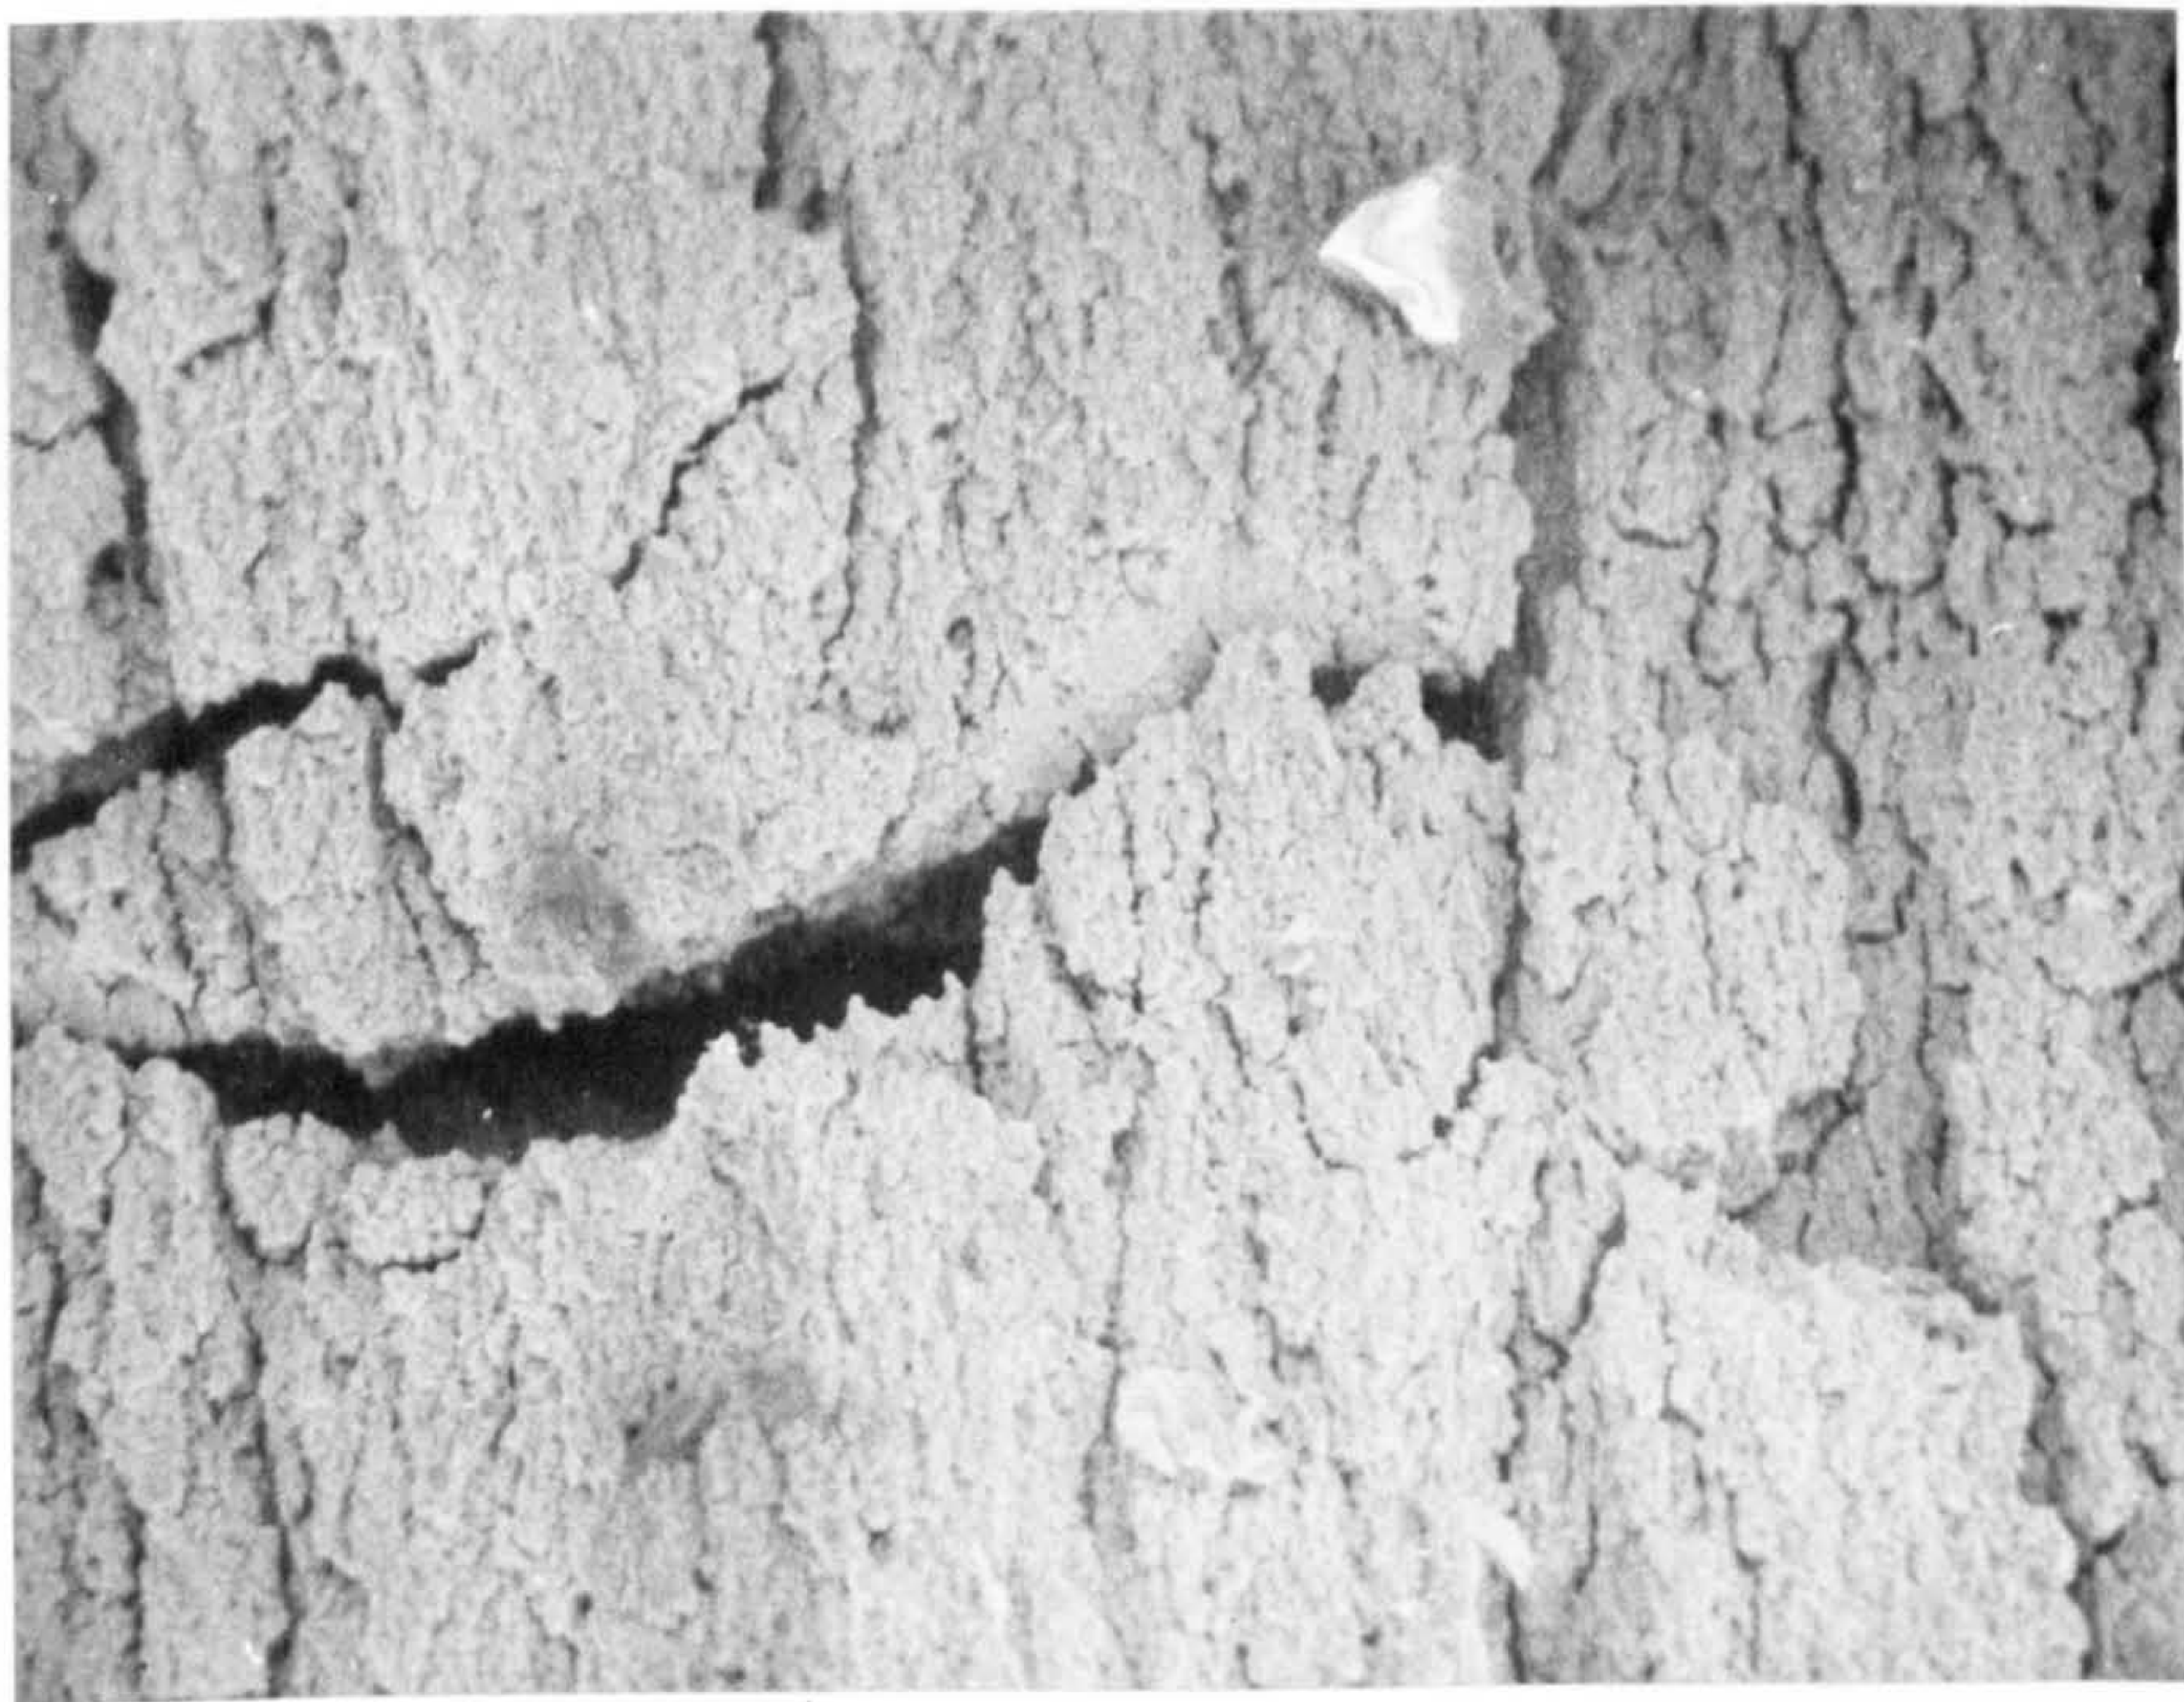
Fig. 3.16 Intergranular cracking in cold worked material  
as viewed in the S.E.M. (300x)

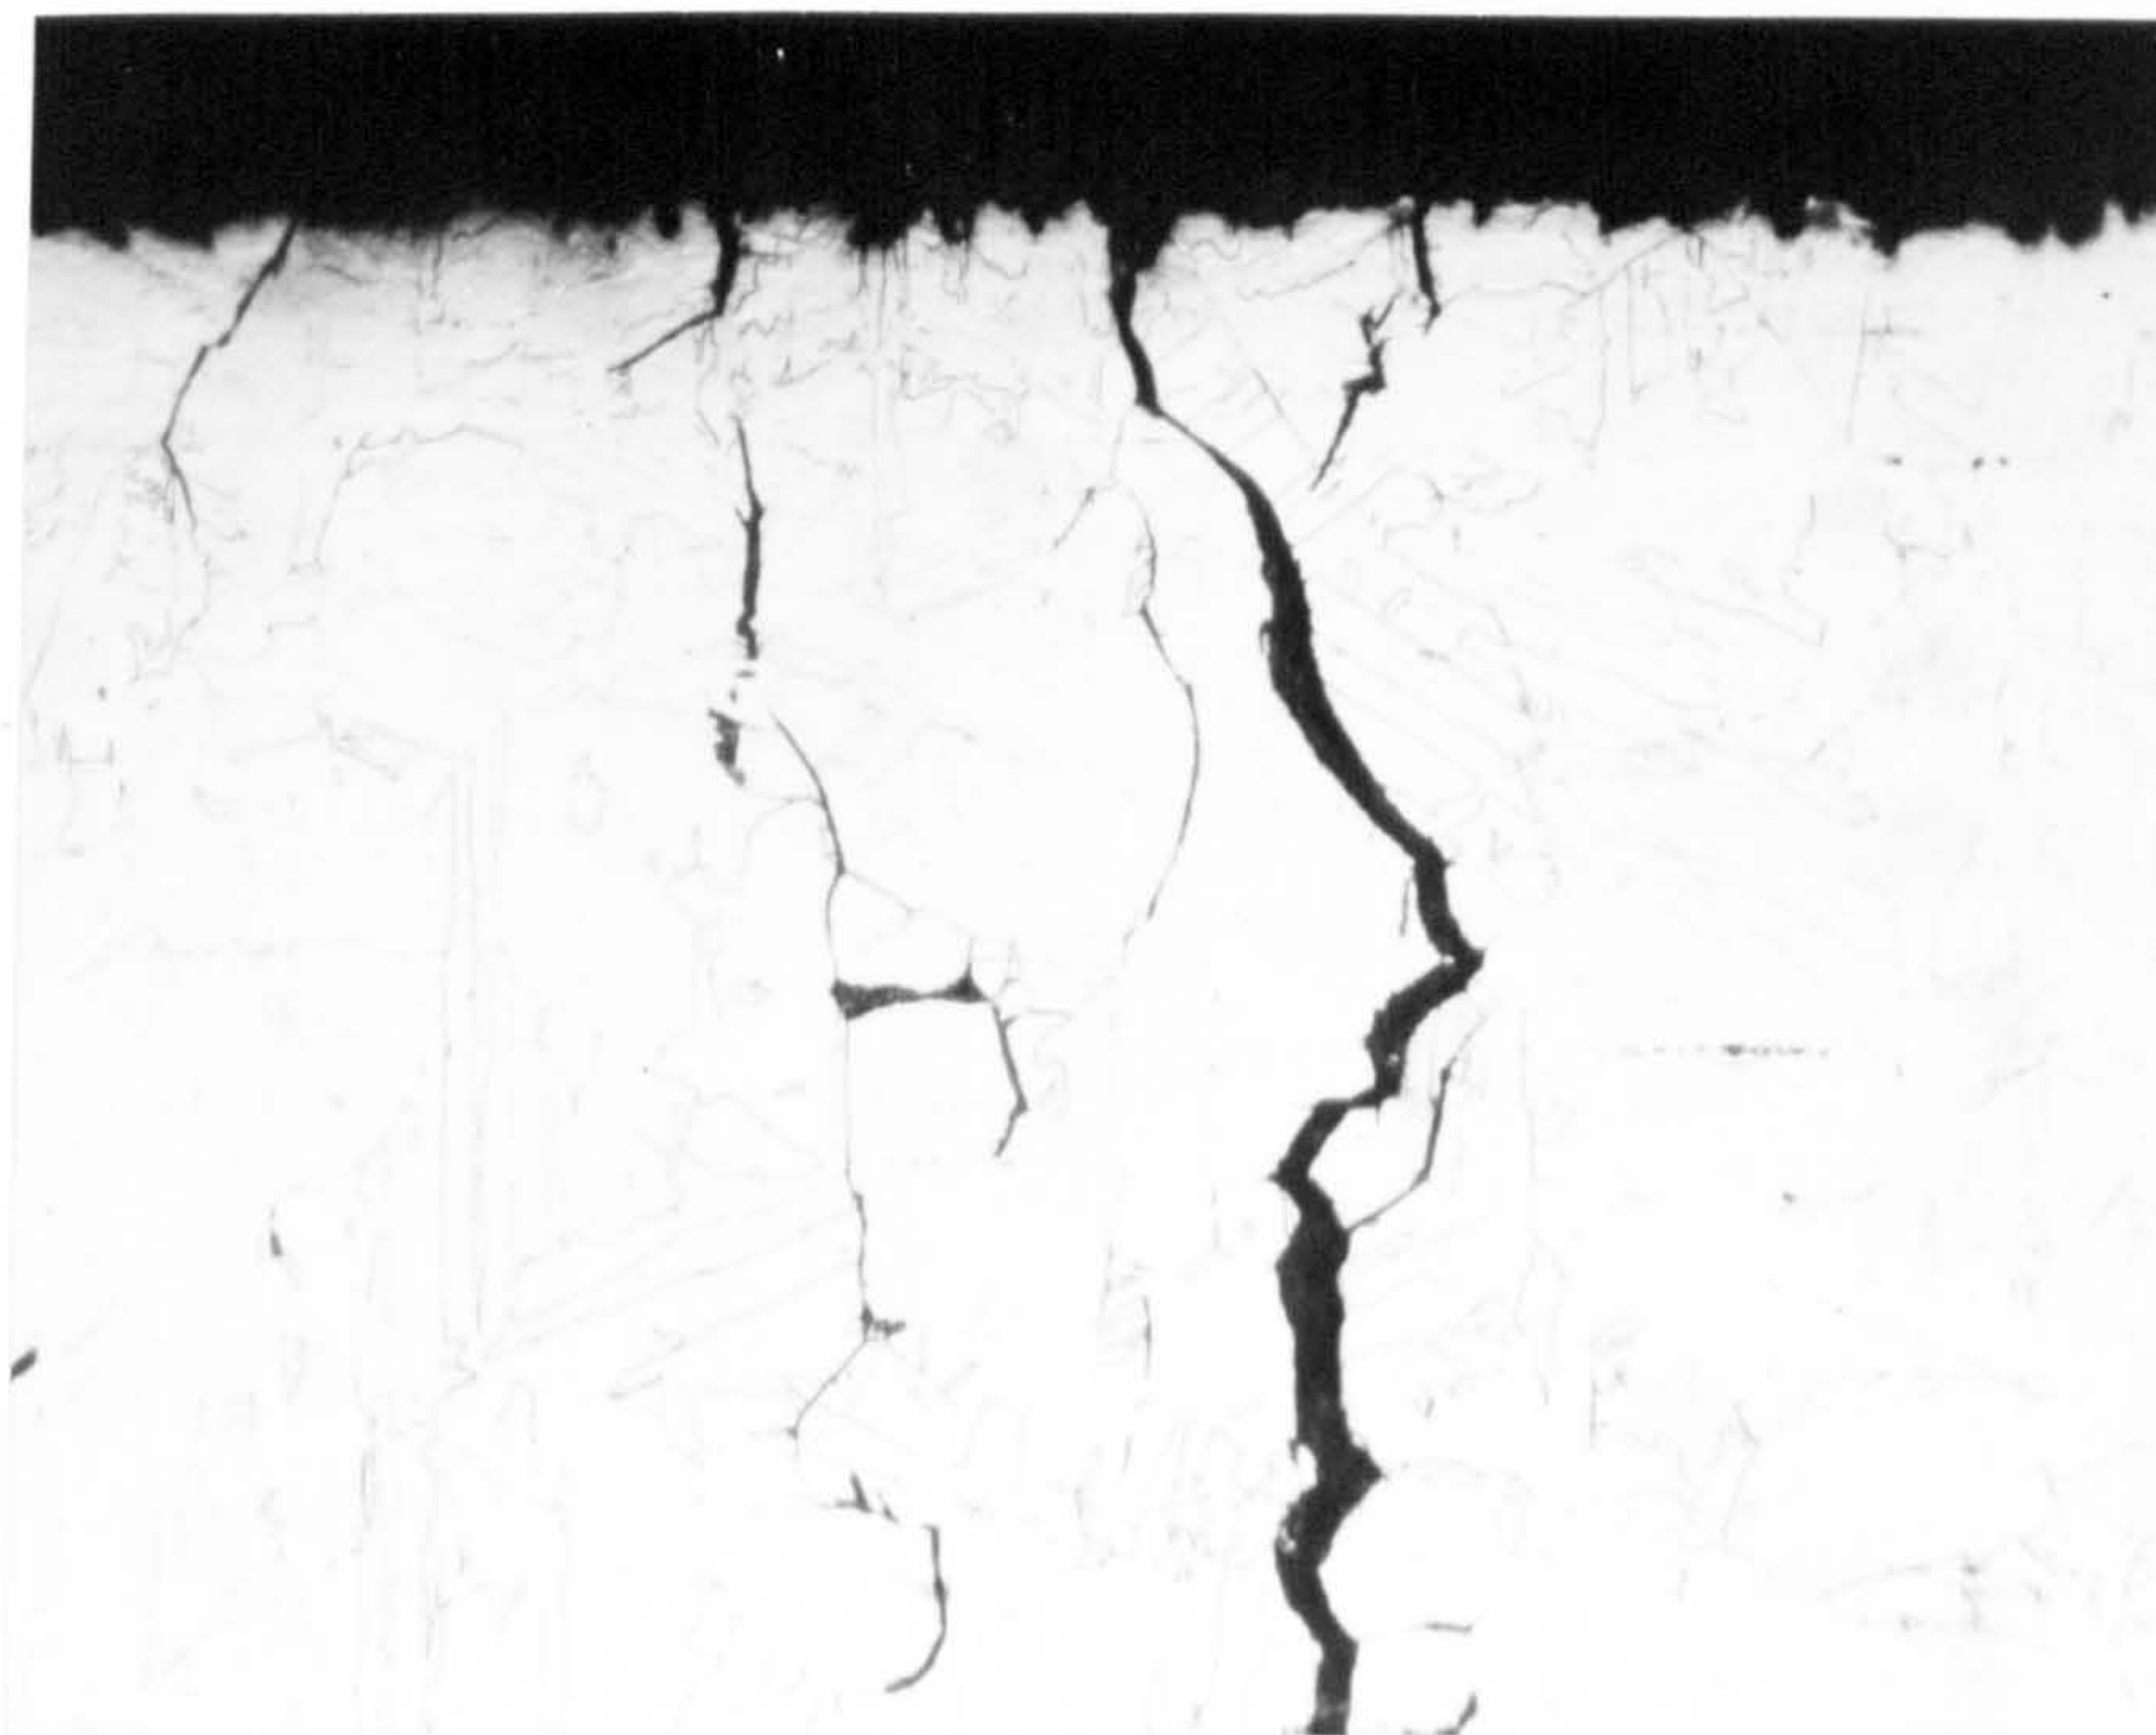
Fig. 3.20 Association of surface fissures and intergranular cracking (300x)

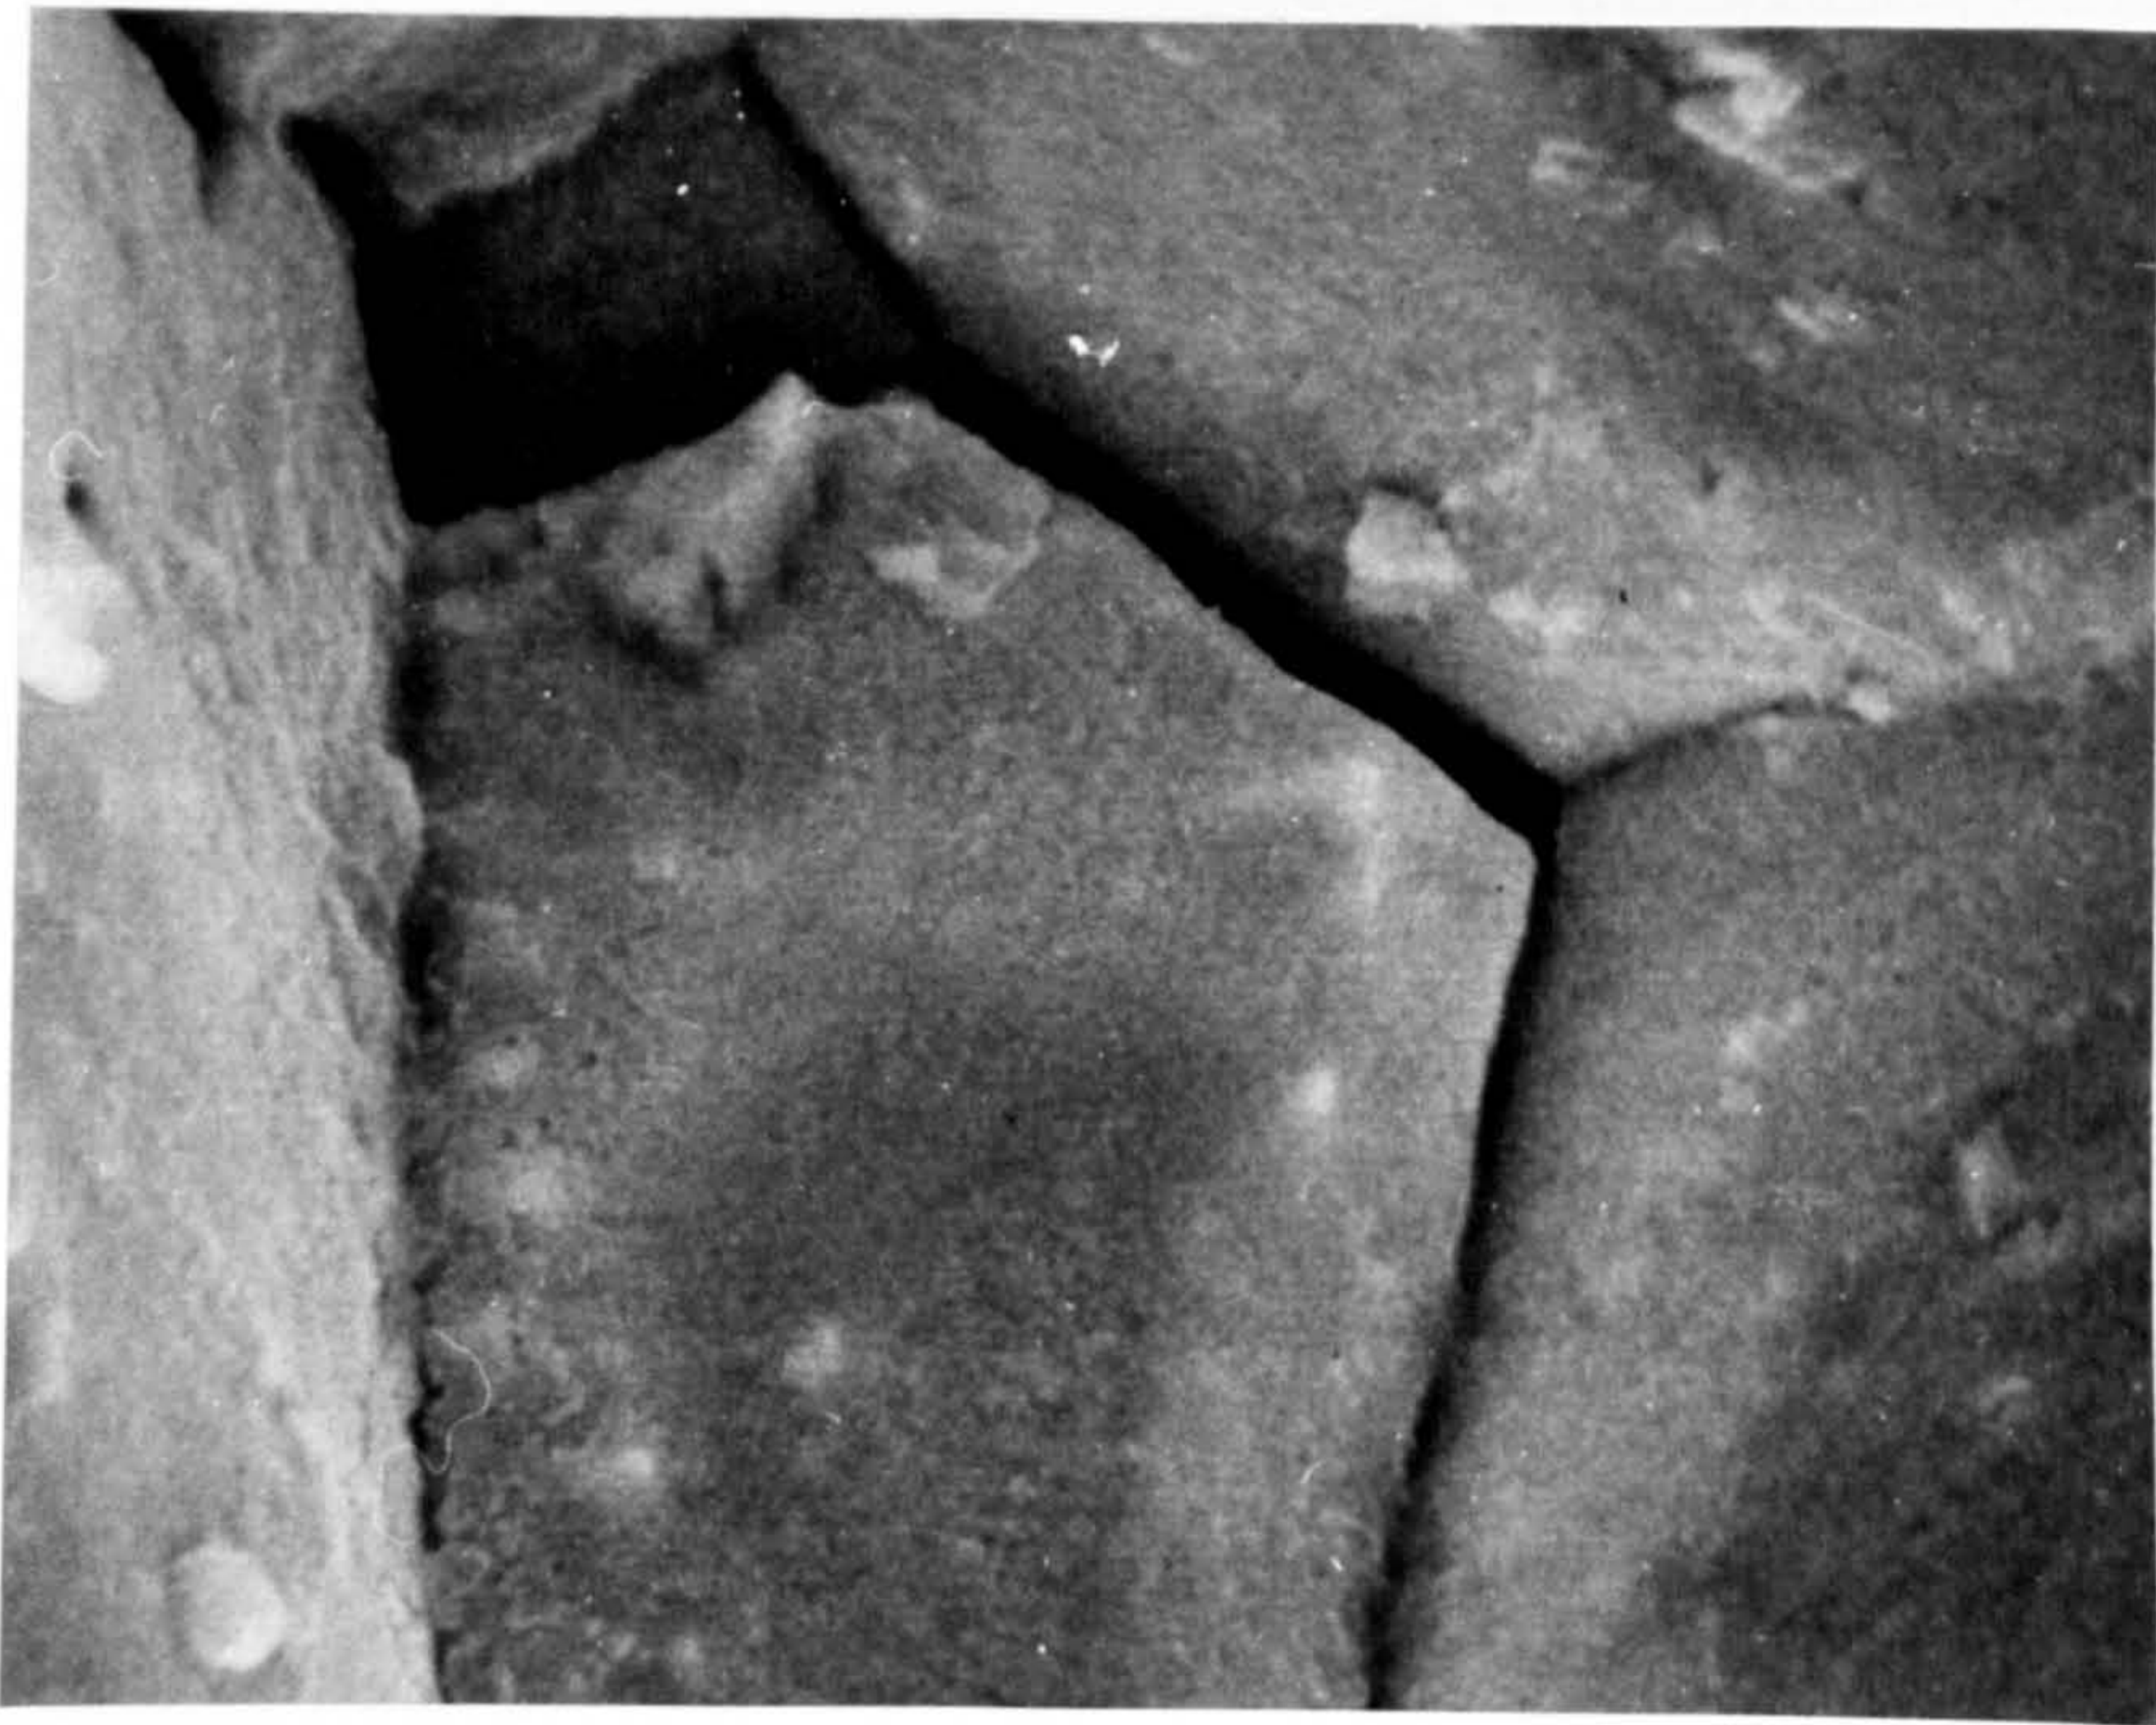
Fig. 3.45 Intergranular stress corrosion fracture surface (2,300x)

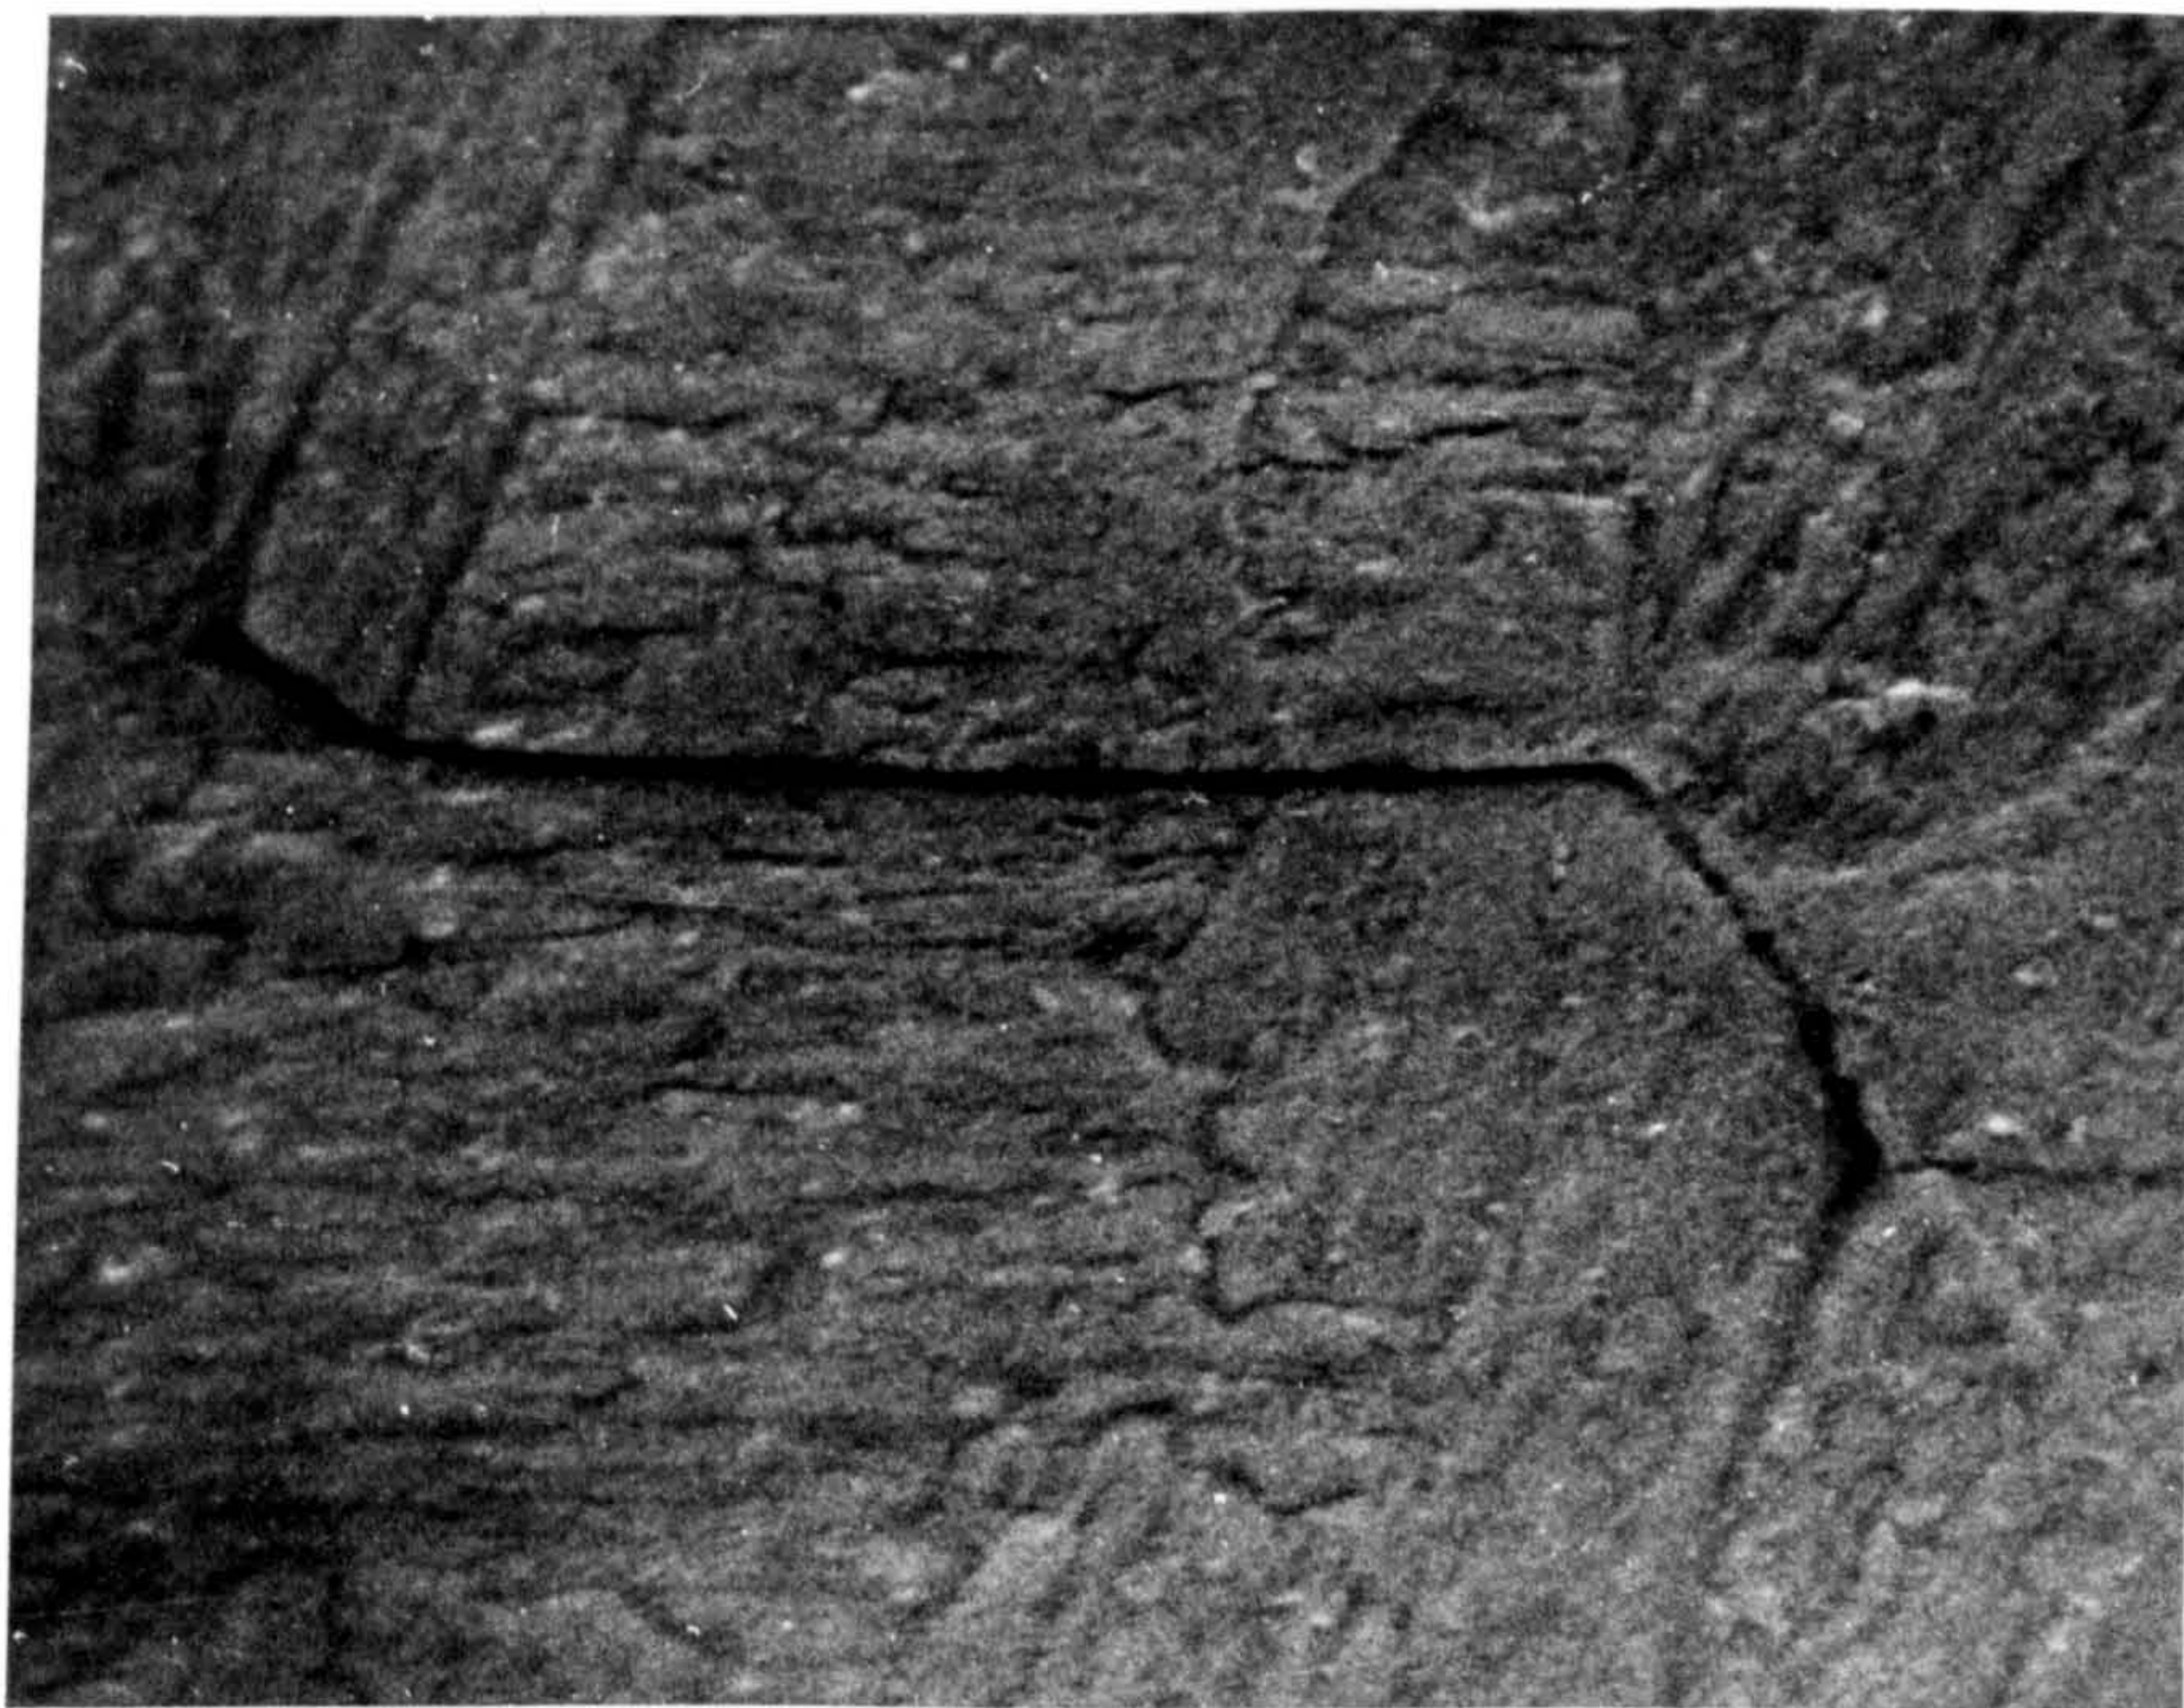
Fig. 3.51 Crack initiation along grain boundary region. Material stressed for 15 minutes in a solution containing chloroplatinic acid. (2,350x).

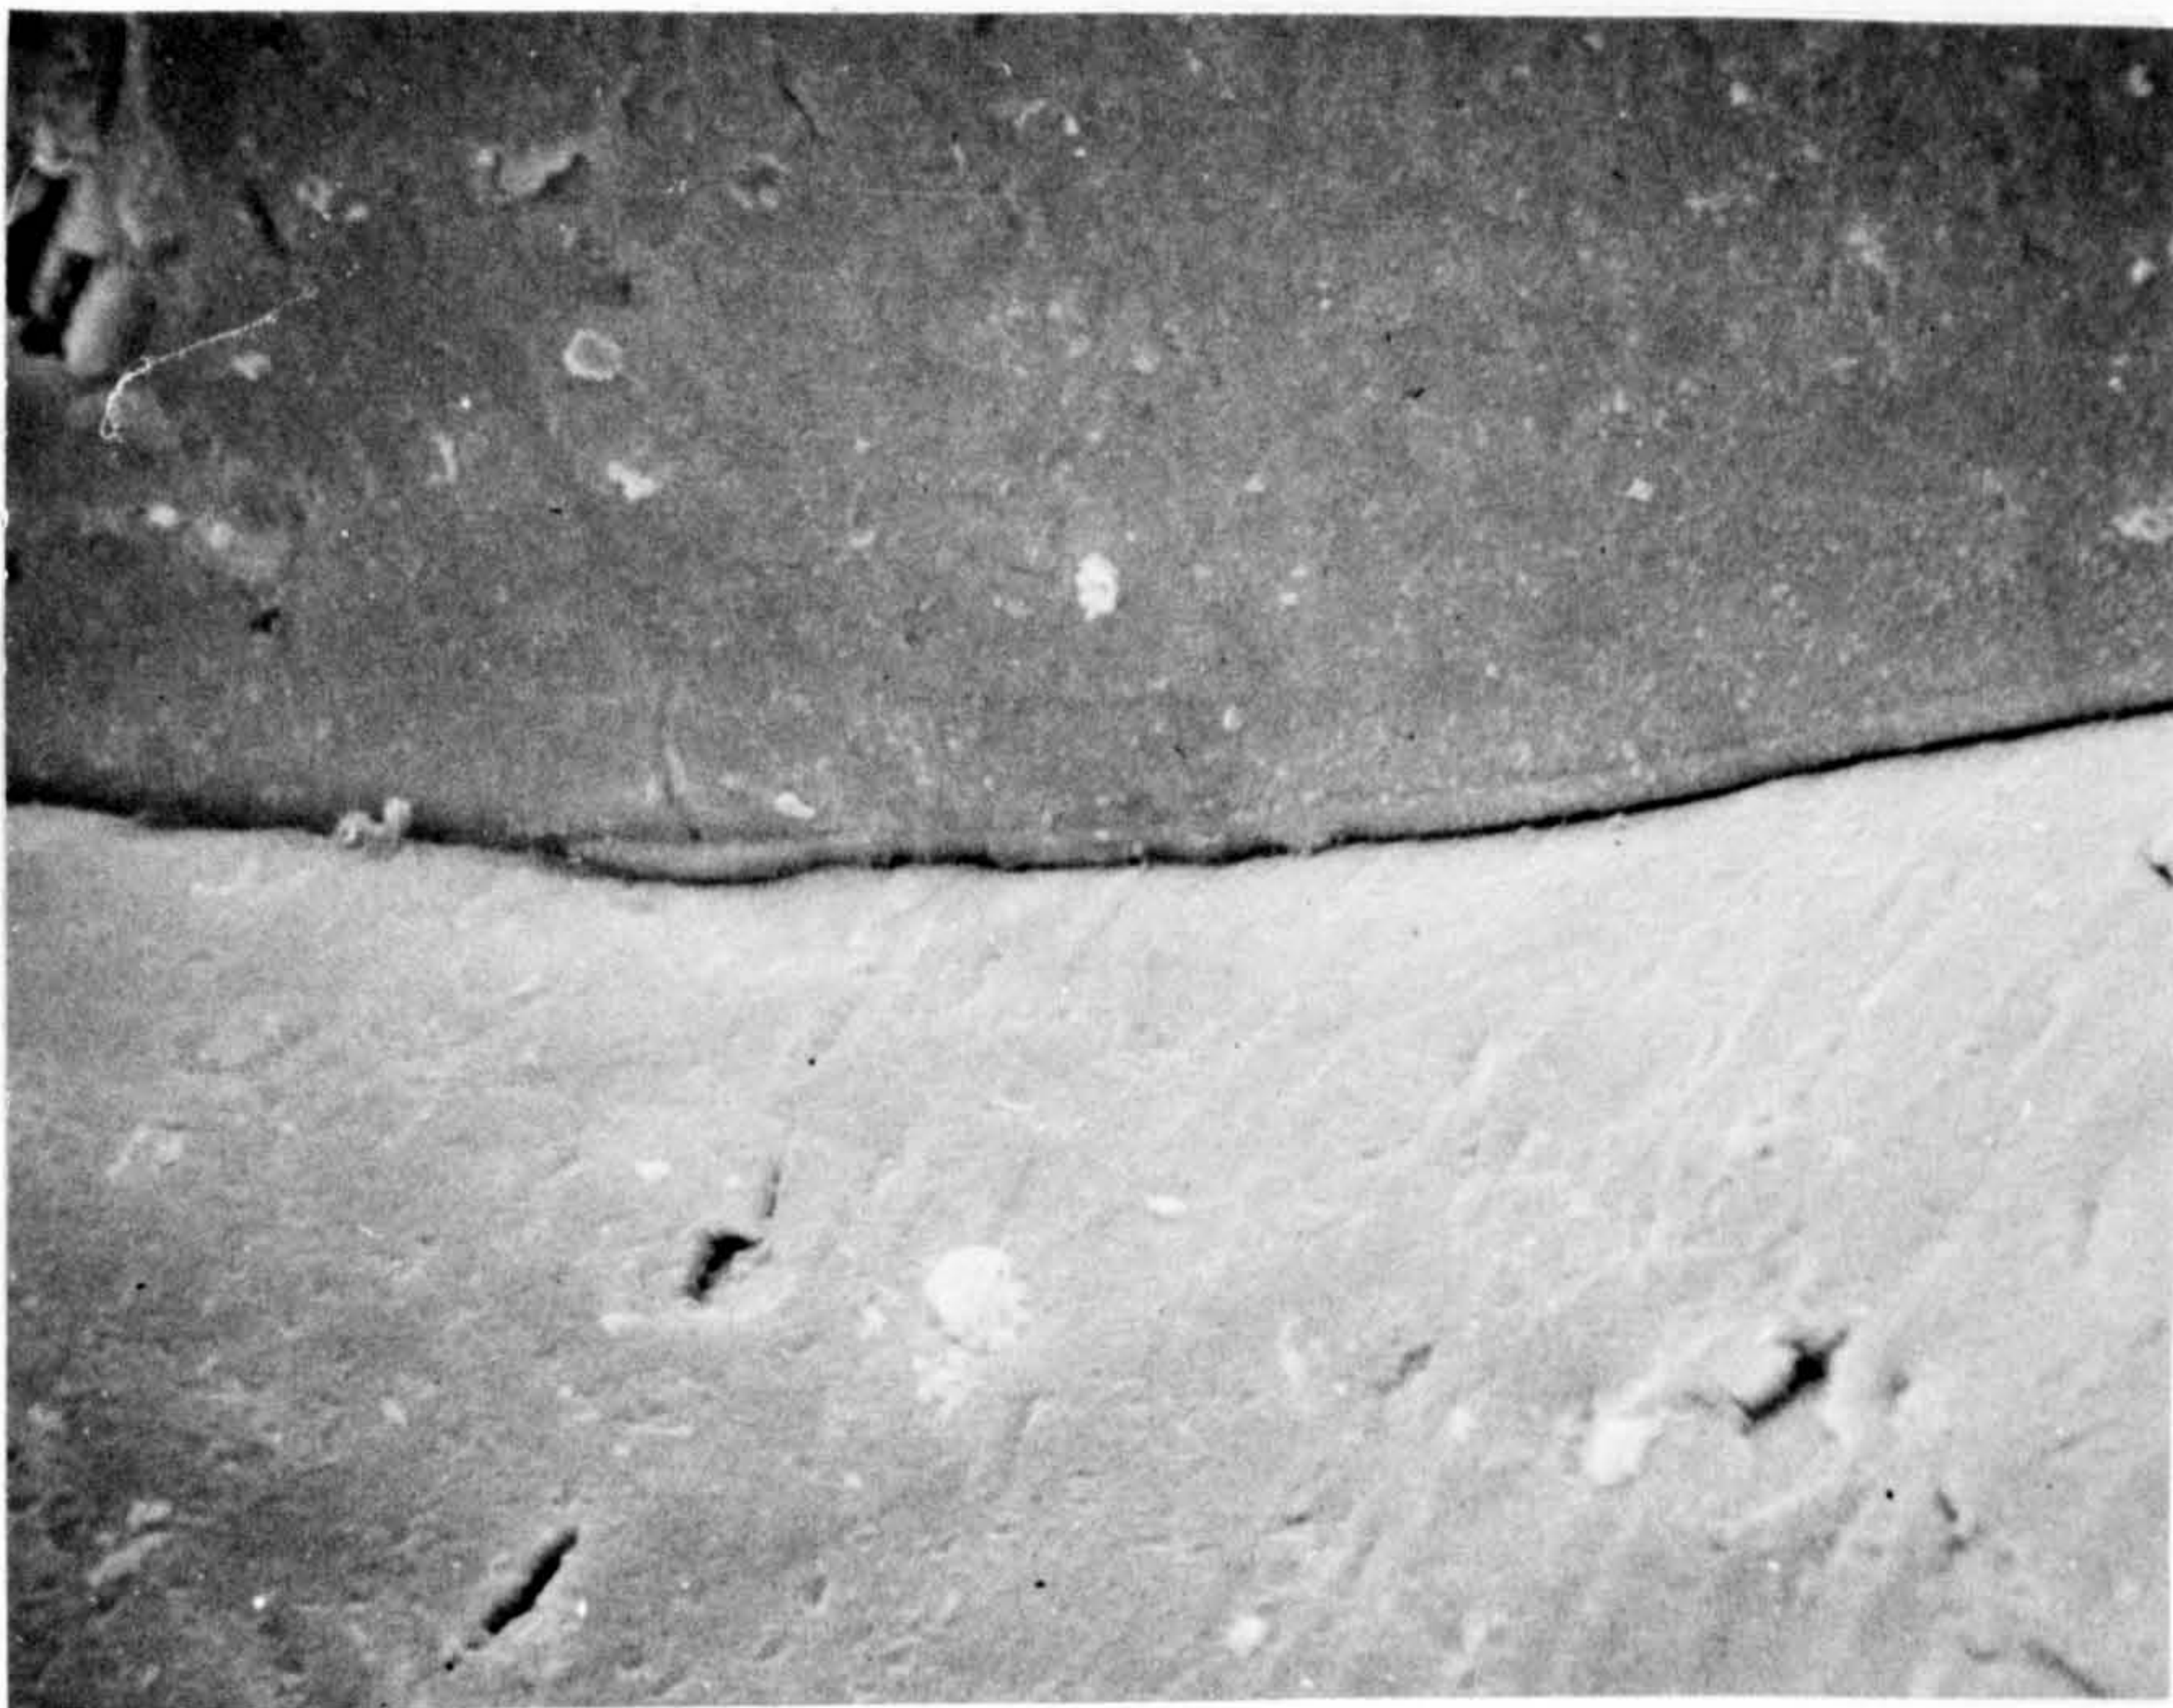
Fig. 3.69 (a) Intergranular area of hydrogen embrittlement failure (2,500x)

(Fig. 3.68). When intergranular areas were present these appeared featureless and showed no markings characteristic of cleavage (Fig. 3.69). The latter appeared to be of the continuous type, but on some steps evidence was found of what may be shear rupture (Fig. 3.70).
